APPENDIX H

**Phipps Ocean Park Borrow Area
Video Survey**

FINAL REPORT

March 2002

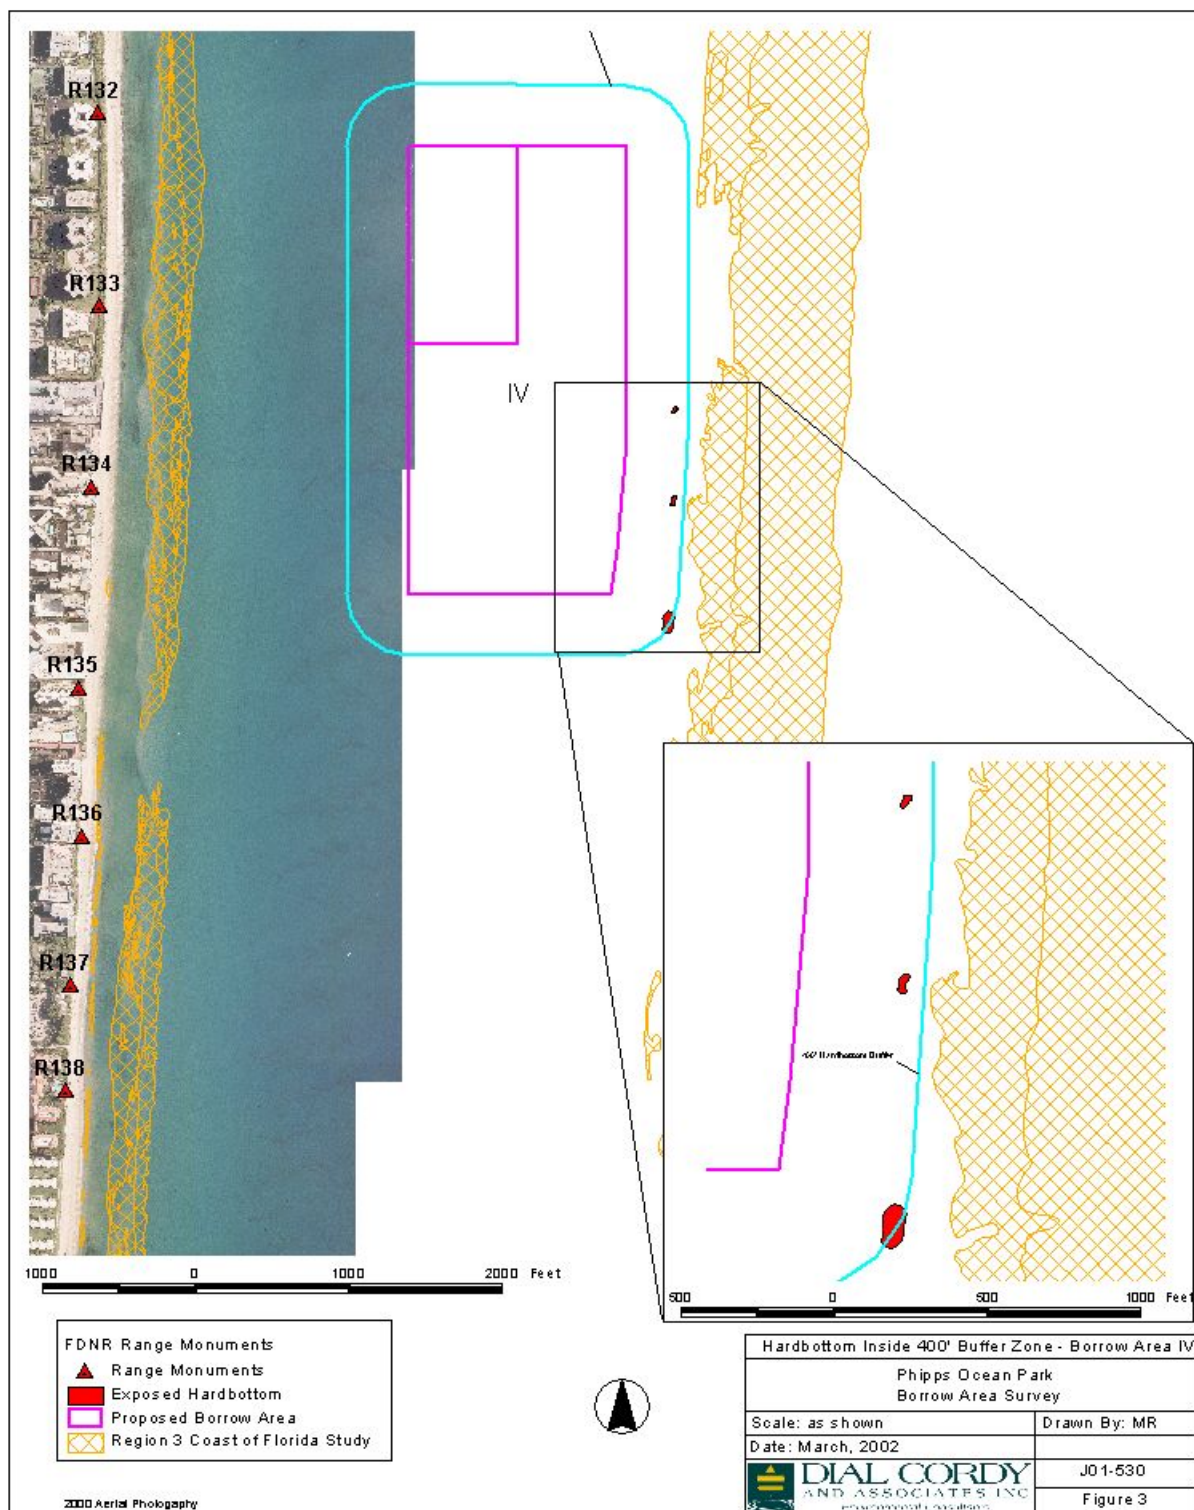
Figure 3 Hardbottom Inside 400-Foot Buffer Zone - Borrow Area IV

Results of this survey indicate the presence of three distinct hardbottom areas within the proposed 400-foot buffer for Borrow Area IV. The relative size and location of the hardbottom areas located is shown on Figure 3. These three areas of exposed rock are typical of hardbottom communities in South Florida and are similar in composition to those described by CSA (2000) in their preliminary mapping effort.

Since the existing boundaries for the borrow areas did not include an extensive survey of the potential borrow areas, it is our recommendation that modifications to the existing borrow area boundaries be made to incorporate these hardbottom areas and move the existing cut boundary of Borrow Area IV to accommodate this. There were no other hardbottom resources found within the remainder of Borrow Area IV or within the boundaries of Borrow Area III.
